Acetylene Incident

Why we don't store acetylene
in a closed up vehicle!

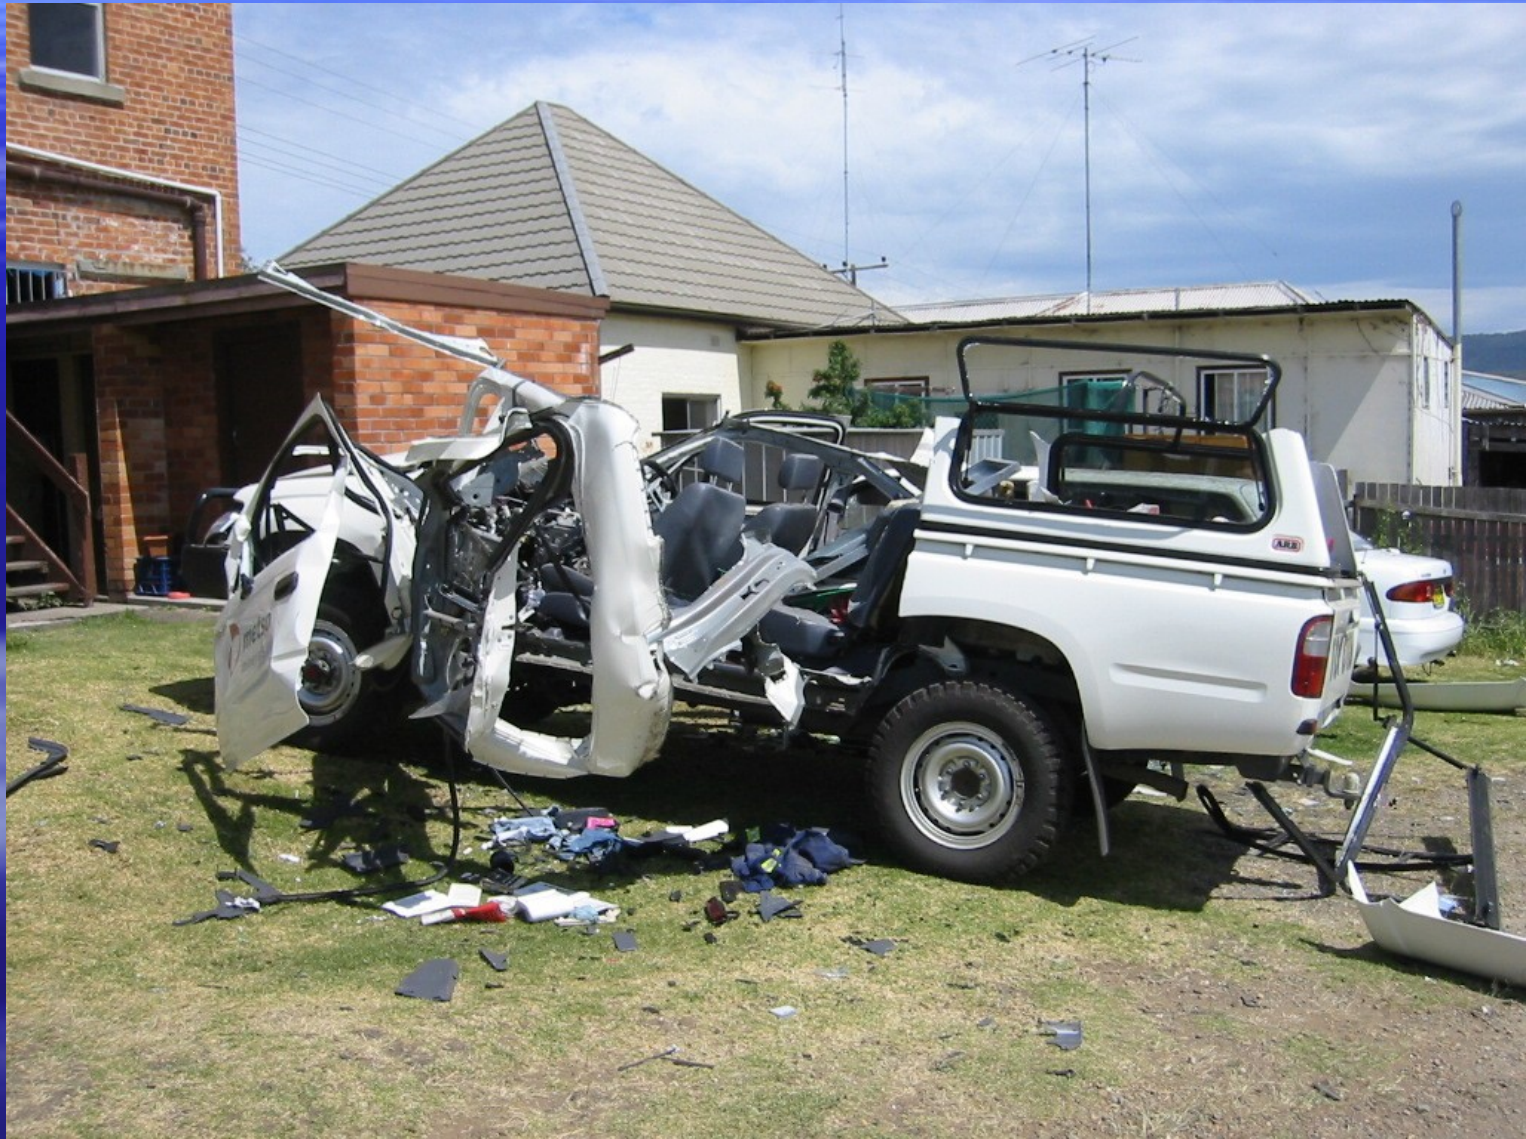
- This is an incident in Newcastle. It happened on Monday the 29th of September. A fitter with a works van left an E size Oxygen and Acetylene cylinder on the back seat of a Toyota dual cab over the weekend. The Acetylene cylinder must not have fully closed and a small leak occurred.
- Over the weekend the Acetylene had accumulated in the van. On the Monday morning the fitter approached the van and opened the door, a large explosion took place. We believe the ignition could have been caused by either the internal light, the automatic door control or by a mobile phone which was on the front seat of the van. The fellow was also a smoker. He has damage to his ear drums and facial damage. As you can see by the attached photos he was very lucky.

Modified Toyota Pick-up

- FLAMMABILITY LIMITS (% by volume in air): Lower: 2.5 Upper: 100 – **an extremely wide range!!!!**
- Use or store only in a well-ventilated area. (**inside of the truck is not well ventilated**)
- NFPA RATINGS: Health 1; **Flammability 4**; Reactivity 3;

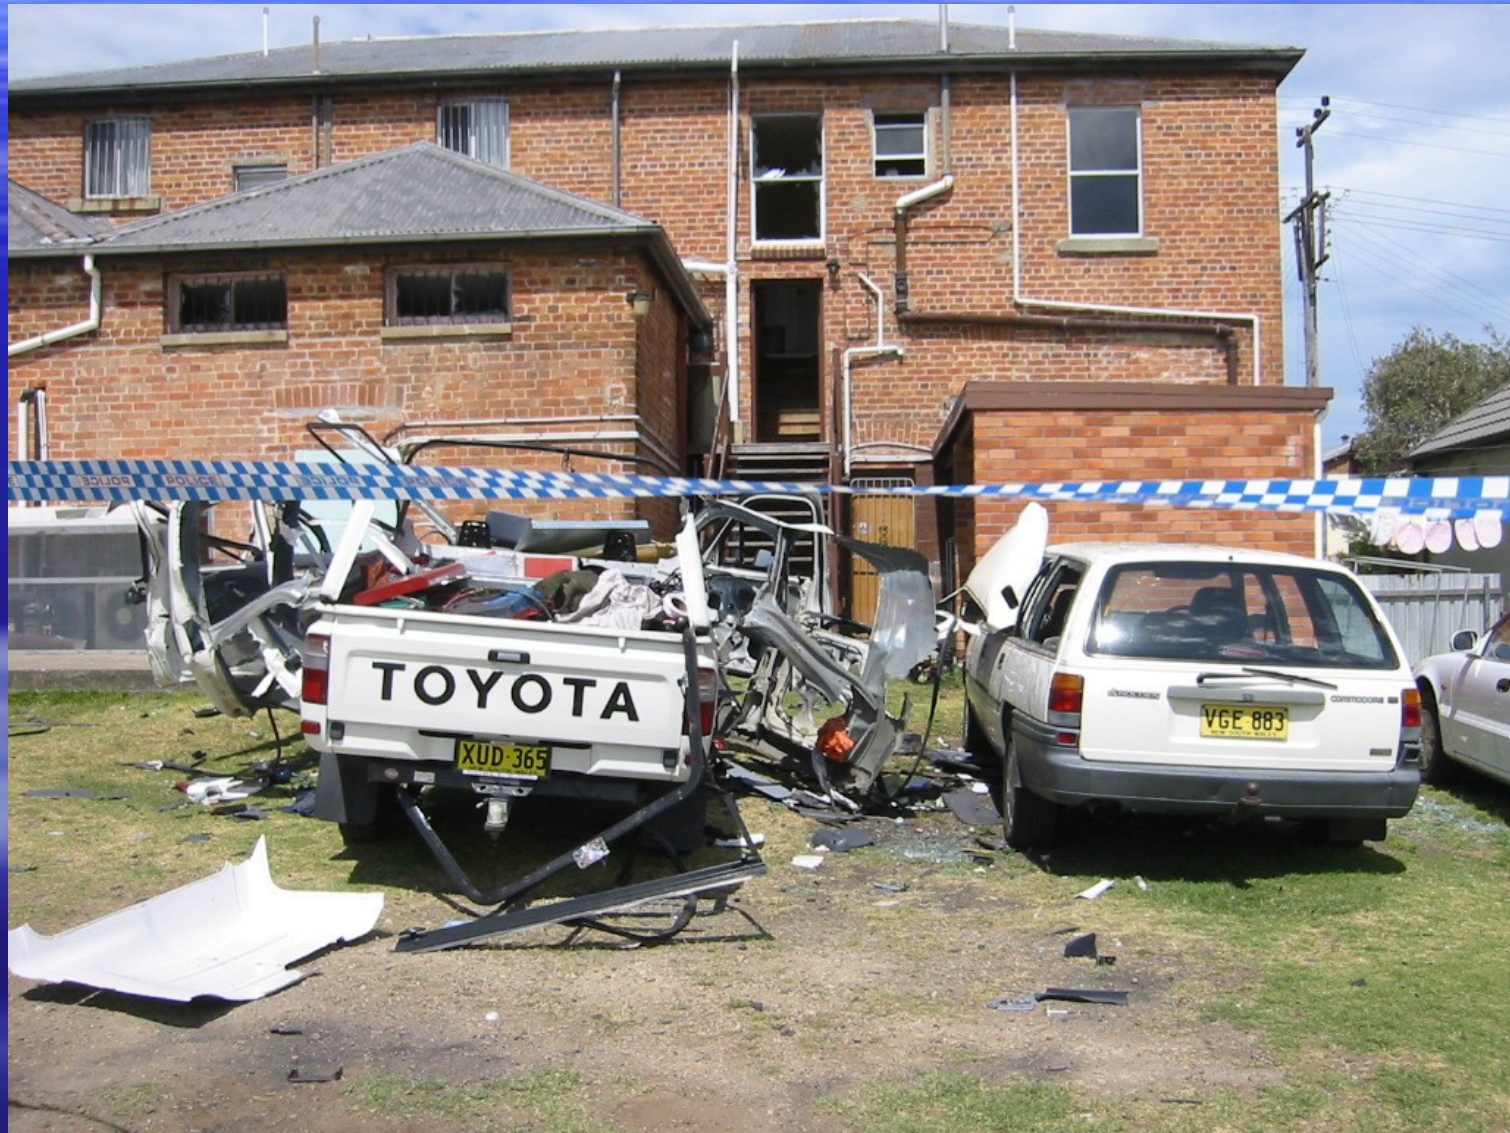
Wider Perspective

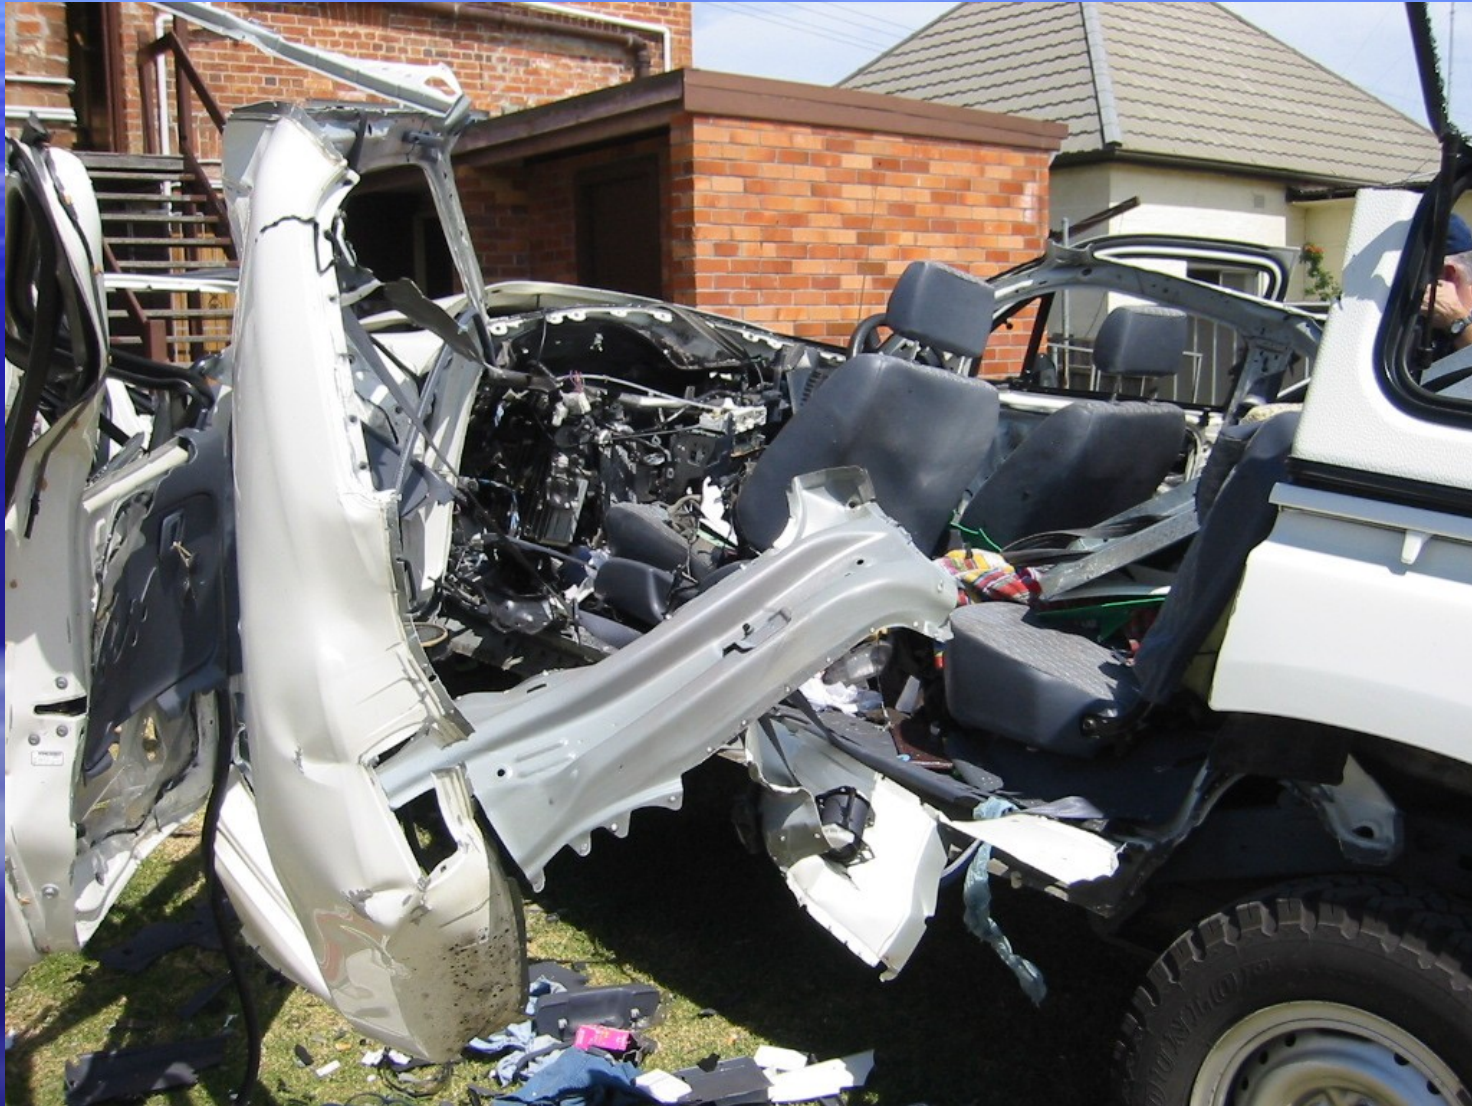
Close-up inside the cab
